**DEPARTMENT OF TRANSPORTATION****DIVISION OF ENGINEERING SERVICES**

Contract #: 04-0120F4Cty: SF/ALA Rte: 80 PM: 13.2/13.9File #: 69.15**SOURCE INSPECTION REPORT****Resident Engineer:**Siegenthaler, Peter**Address:** 333 Burma Road**City:** Oakland, CA 94607**Report No:** SIR-003406**Date Inspected:** 16-Jun-2011**Project Name:** SAS Superstructure**OSM Arrival Time:** 1900**Prime Contractor:** American Bridge/Fluor Enterprises, a JV**OSM Departure Time:** 700**Contractor:** Zhenhua Port Machinery Company, Ltd (ZPMC), Changxing Island **Location:** Shanghai, China**Quality Control Contact:** Mr. Don Walton**Quality Control Present:** Yes No**Material transfer:** Yes No N/A**Sampled Items:** Yes No N/A**Stock Transfer:** Yes No N/A**OK to Cut:** Yes No N/A**Rebar Test Witness:** Yes No N/A**Delayed/Cancelled:** Yes No N/A**Other:** Coating Inspection**Bridge No:** 34-0006**Component:** OBG**Bid Item:** 77, 78, 79**Lot No:** B #204**Summary of Items Observed:**

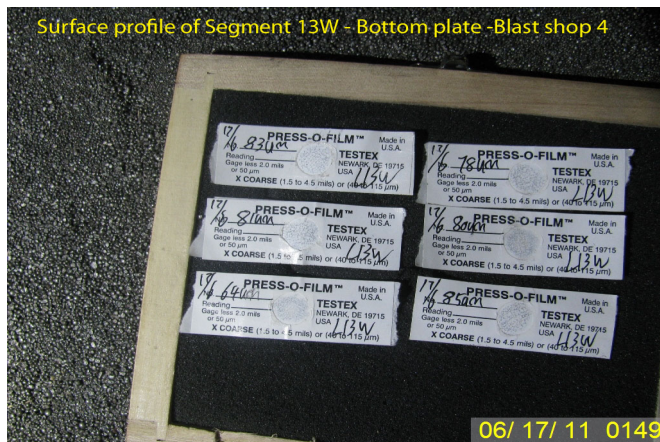
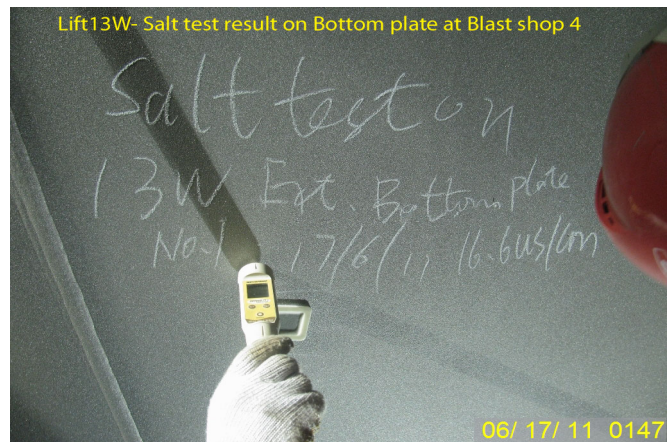
For further informations, Please see the pictures below,
